Becica Associates was part of a team of consultants whose goal was to identify the cause of water penetration and other structural deficiencies in the 27 story steel and concrete framed hotel and casino. The building façade was the main concern and our challenge was to devise a responsive repair scheme that did not change the building's appearance and did not interrupt casino operations.

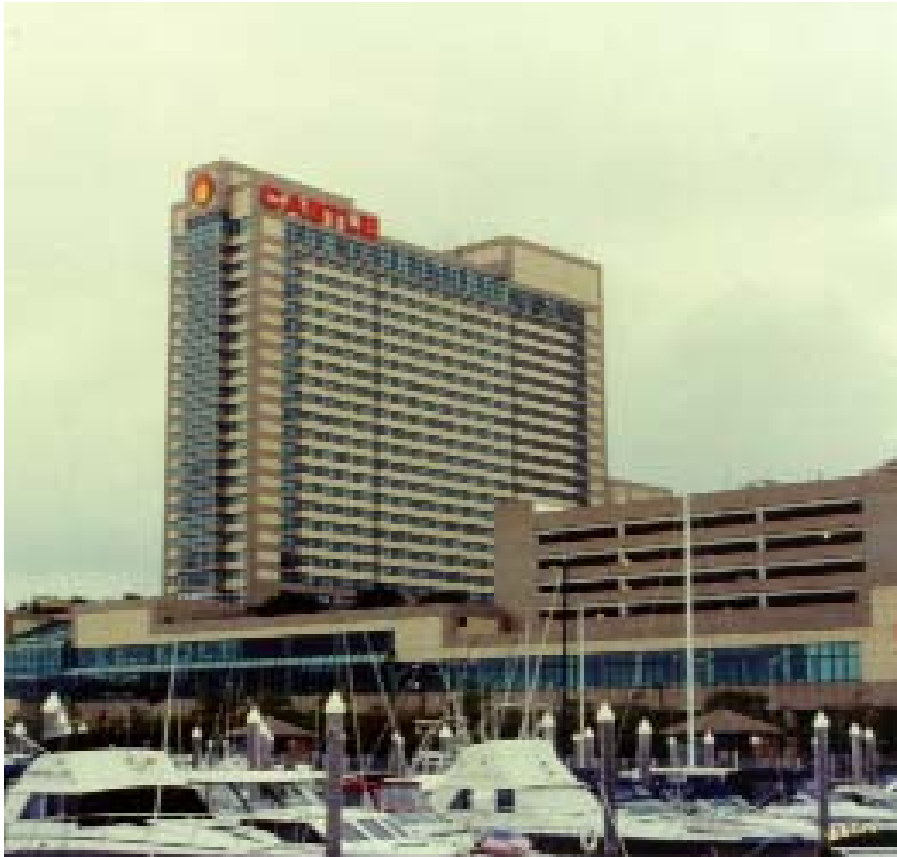
The façade evaluation we performed included a detailed survey, analysis and report of existing conditions. Four swing staging "drops" representing 10% of the brickwork surface area were randomly selected. Using a ten power measuring magnifier, every mortar joint crack larger than 0.1mm was noted and plotted onto an accurate building elevation.

Façade cracking was analyzed to establish the statistical importance of the extent of water penetration through the brickwork itself and to evaluate the most probable cause of cracking.

Other observations included the lack of head and sill flashing and an improperly terminated through wall flashing throughout the project.

- Installing new vertical movement joints in the brickwork
- Fill mortar joint cracks using the "Bag & Grout" technique
- Spot repair deficient through-wall flashing
- Add window head and sill flashings.
- Replace window gaskets and sealants.
