Balcony Repair and Sliding Glass Door Replacement

5000 BOARDWALK CONDOMINIUMS

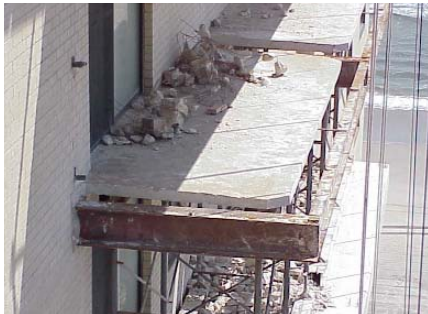
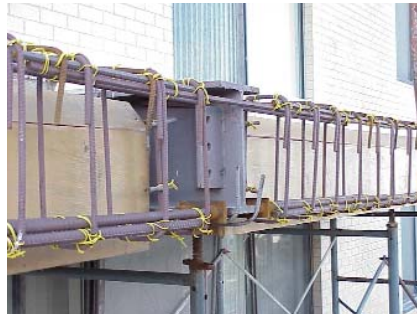
Falling concrete from balcony beam soffits was first reported in 1985. Over the years, various repairs were implemented to reduce the obvious pedestrian hazards.

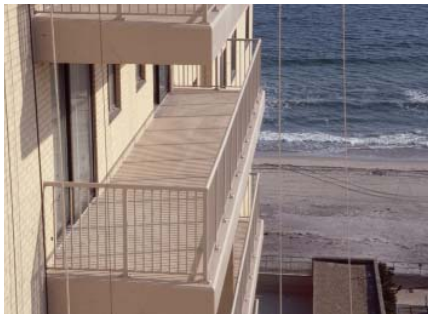
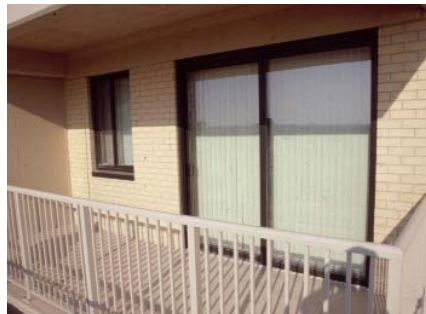
In the fall of 1996, Becica Associates was retained to assist the owner in determining the structural serviceability of the balcony framing and to address long-term repair solutions. Becica Associates completed a number of investigations to determine the cause of the failures. Testing included crackmapping, sounding, visual inspections, chloride analyses, steel thickness measurements and full scale load testing.

Design for balcony repairs includes replacing edge beam concrete while maintaining existing balcony slabs. New balcony coatings, guard rails and sliding glass doors were also included.
